SUBJ: RCRA Compliance Evaluation Inspection
Kohler Company
EPA ID Number: ALD05702558

RCRA Inspection Report

Kohler Company
176 Cochran Road
Huntsville, Alabama 35824
Sumter County
EPA ID: ALD05702558

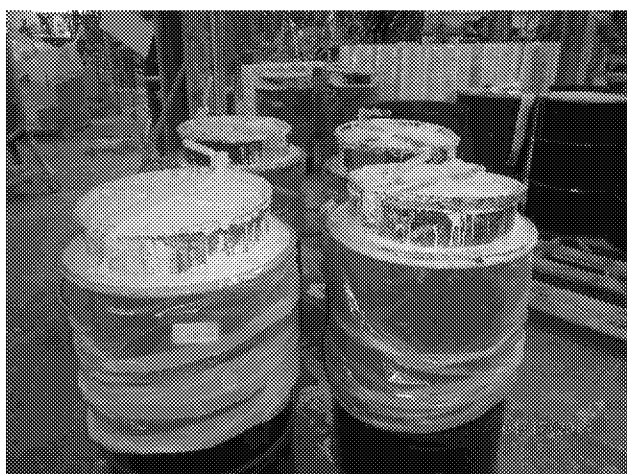
At the time of the inspection, the inspectors observed four empty 55-gallon drums being set out as replacement hazardous waste drums (Picture 2); three full 55-gallon drums of hazardous waste flammable liquid acetone (D001, F003) with one drum not labeled (Pictures 3-8); and three full 55-gallon drums of hazardous waste flammable liquid acetone (D001, F003) sitting on a pallet (Pictures 9-10). None of the full drums were dated. Mr. Marquez Fletcher was moving the full hazardous waste drums onto pallets going to the HWSA.

Picture [SEQ Picture * ARABIC] – Vikrell Room hazardous waste drums

The inspectors explained to Mrs. Hitt and Mr. Bastow that only one 55-gallon drum can be in a SAA. The inspectors observed a total of six 55-gallon hazardous waste drums being removed from the area, thus the SAA exemption was exceeded.

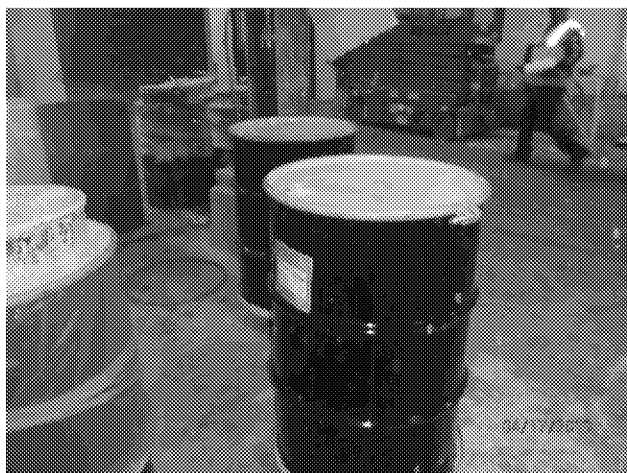
Picture [SEQ Picture * ARABIC] – Vikrell Room hazardous waste drums

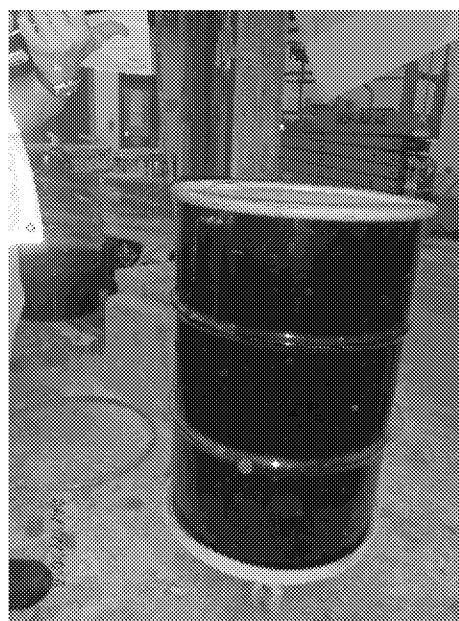
Picture [SEQ Picture * ARABIC] – Vikrell Room hazardous waste drum not labeled

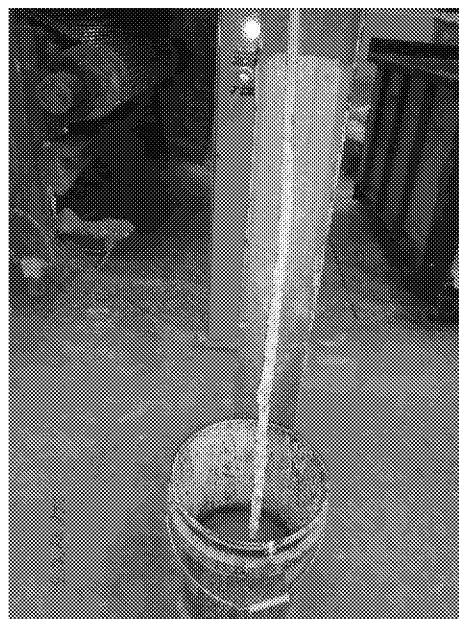
The inspectors then toured the Vikrell® compounding line and observed a 55-gallon SAA drum on the line, a blue 5-gallon container with acetone used to clean the cutter and mop the floor, and a metal mop bucket filled with mop water (Pictures 11-12). The inspectors asked Mrs. Hitt to verify where the spent cleaning acetone and the discarded mop water is disposed of and how often.

Picture [SEQ Picture * ARABIC] – Vikrell Room acetone bucket used for cleaning

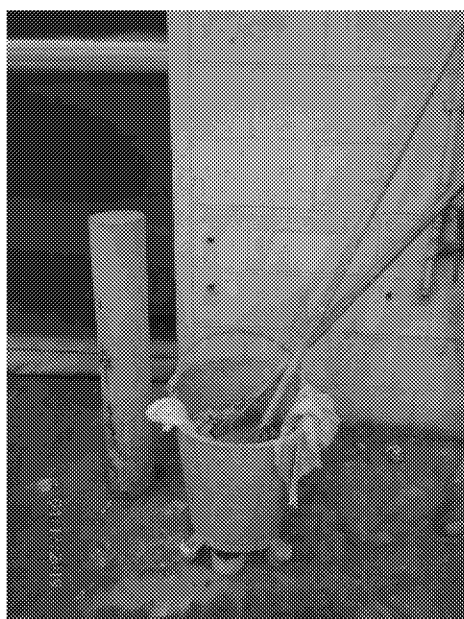
Picture [SEQ Picture * ARABIC] – Vikrell Room mop bucket

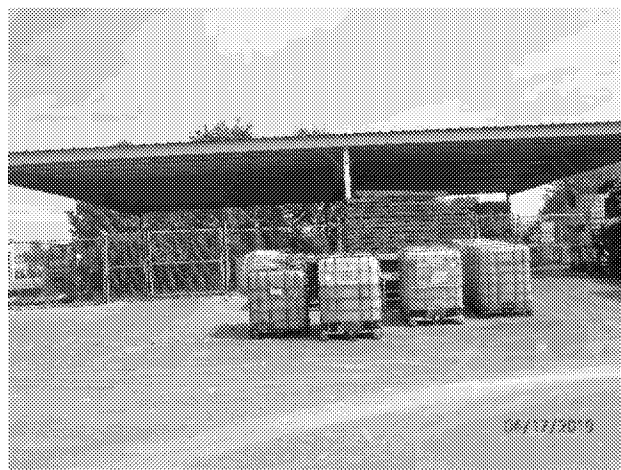
The less than 90-day HWSA was a separate fenced-in area (Pictures 13-14). Next to the HWSA was the Used Oil Storage. In the HWSA, the inspectors observed the following:

The Used Oil Storage is located beside the HWSA (Pictures 13, 15). A fence separates the two storage areas and the Used Oil Storage has its own entrance gate. The inspectors observed the following in this storage area:

Picture [SEQ Picture * ARABIC] – HWSA and Used Oil Storage

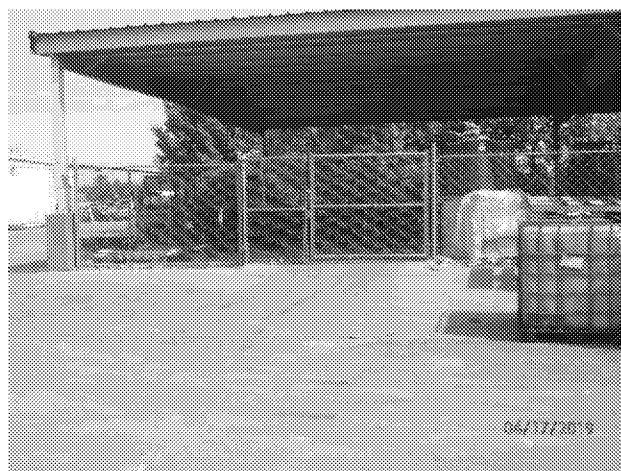
- The “No Smoking” sign missing from each side of the HWSA (Picture 13);
- Three 55-gallon drums of undetermined waste being stored in the front of the HWSA did not have a waste profile or analysis (Picture 16);
- Sixty 55-gallon drums of hazardous waste flammable liquid acetone (D001, F003) (Pictures 17, 20);
- Three 55-gallon drums of resin silo clean out that did not have a waste profile or analysis (Picture 18);
- Three 55-gallon drums of undetermined material sitting on pallets did not have a waste profile or analysis (Picture 19); and
- Metal chains with dried residue from the acetone chain cleaner to be recycled as scrap metal (Picture 21).

Picture [SEQ Picture * ARABIC] – HWSA

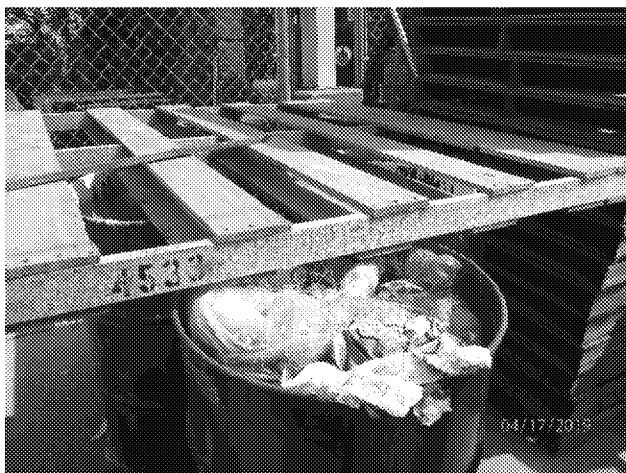
Picture [SEQ Picture * ARABIC] – HWSA drums of unknown waste

Pursuant to ADEM Admin. Code r. 335-14-3-.01(2) [40 C.F.R. § 262.11], a person who generates a solid waste, as defined in ADEM Admin. Code r. 335-14-2-.01(2) [40 C.F.R. § 261.2], must determine if that waste is a hazardous waste following the methods articulated in ADEM Admin. Code r. 335-14-3-.01(2) [40 C.F.R. § 262.11]. Nine 55-gallon drums of undetermined waste did not waste profiles or analyses.

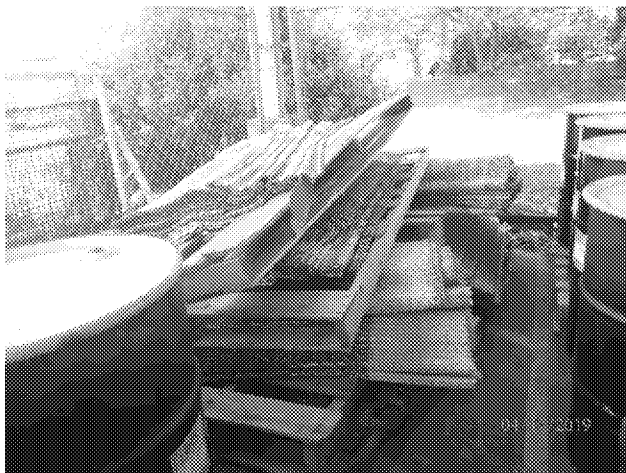
Picture [SEQ Picture * ARABIC] – HWSA metal chains with dried material

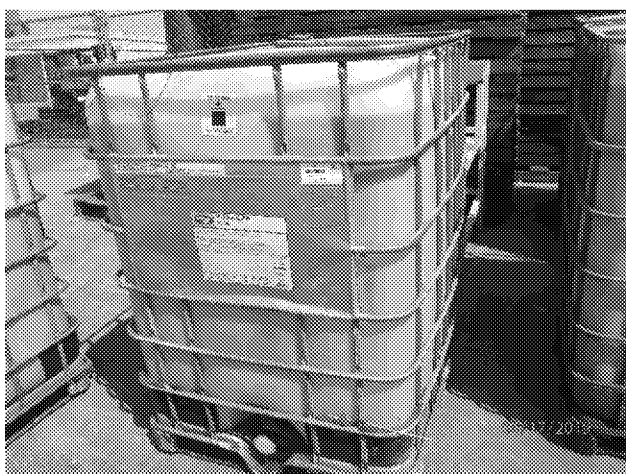
- Five 250-gallon totes of wastewater generated from the Silo Containment Pit was stored as used oil in front of the storage area (Picture 22-23). One of the totes was not labeled “Used Oil;”
- Inside the area were twenty 250-gallon totes, stacked, closed and labeled (Pictures 24, 28);
- A blue metal used oil filter station with a 5-gallon container of used oil underneath (Pictures 25-27). The 5-gallon container was not labeled and not closed; and
- A white 55-gallon drum of used oil that was not labeled and not closed; (Pictures 29-31)

Picture [SEQ Picture * ARABIC] – Used oil tote unlabeled

Pursuant to ADEM Admin. Code r. 335-14-17-.03 (4)(c)1., [40 C.F.R. § 279.22(c)(1)], containers and aboveground tanks used to store used oil at generator facilities must be labeled or marked clearly with the words “Used Oil.”

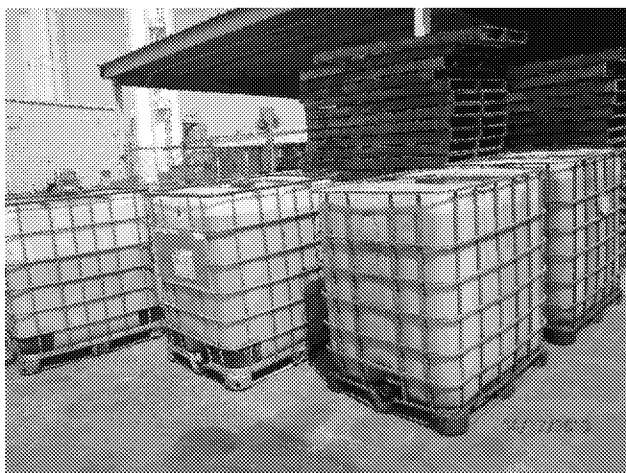
Picture [SEQ Picture * ARABIC] – Used oil totes

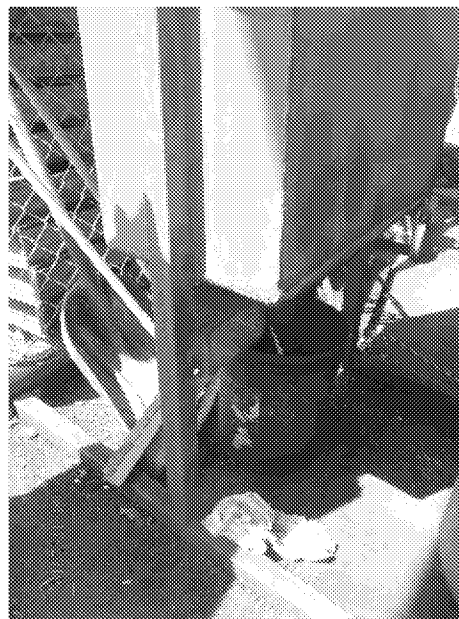
Picture [SEQ Picture * ARABIC] – Used oil storage container open

Pursuant to ADEM Admin. Code r. 335-14-17-.03 (4)(a)1., A container holding used oil must always be closed during storage, except when it is necessary to add or remove used oil.

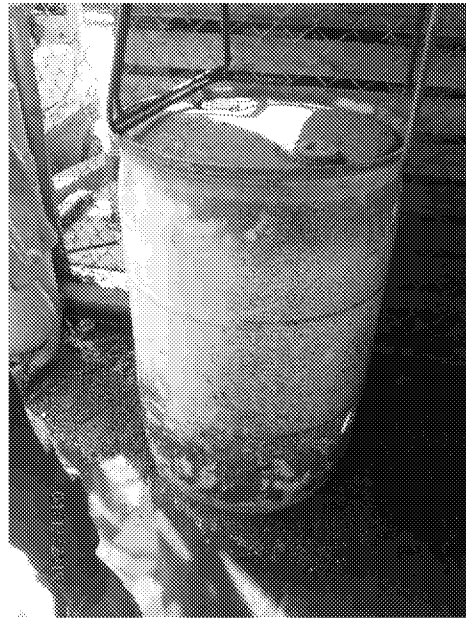
Picture [SEQ Picture * ARABIC] – Used oil storage white use oil drum open, unlabeled

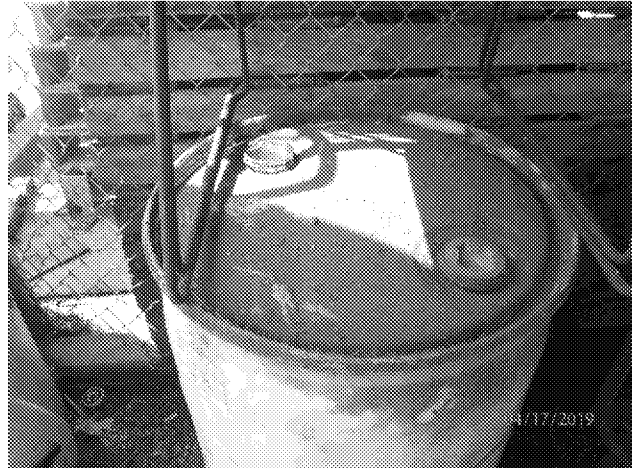
Picture [SEQ Picture * ARABIC] – Used oil storage white use oil drum open, unlabeled

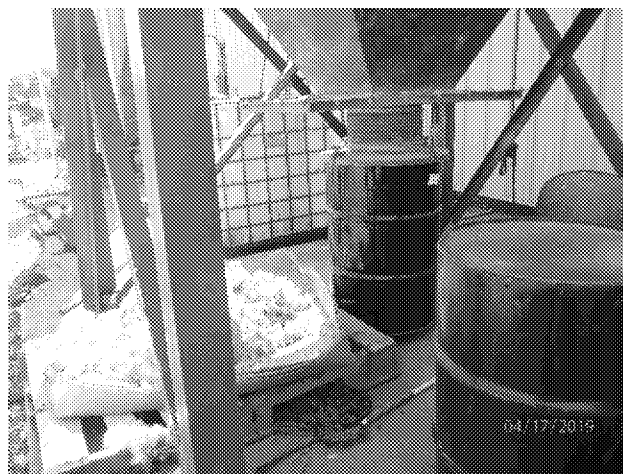
The dust collector for the Vikrell Room was located outside of the building. The inspectors observed in this area the dust collector baghouse hopper for the Vikrell Room, a 55-gallon drum connected to the baghouse hopper that was not labeled and did not have a waste profile or analysis (Picture 33), two 55-gallon drums of undetermined waste filled with rain water (Picture 32), and discarded fiberglass on cardboard (Picture 34).

Picture [SEQ Picture * ARABIC] – Vikrell Dust Collector drum unlabeled

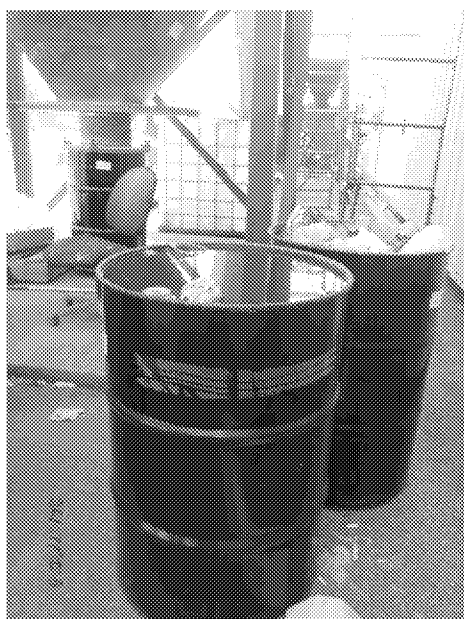
Picture [SEQ Picture * ARABIC] – Vikrell Dust Collector unknown waste drum

Pursuant to ADEM Admin. Code r. 335-14-3-.01(2) [40 C.F.R. § 262.11], a person who generates a solid waste, as defined in ADEM Admin. Code r. 335-14-2-.01(2) [40 C.F.R. § 261.2], must determine if that waste is a hazardous waste following the methods articulated in ADEM Admin. Code r. 335-14-3-.01(2) [40 C.F.R. § 262.11]. Three drums of undetermined waste were stored in this area.

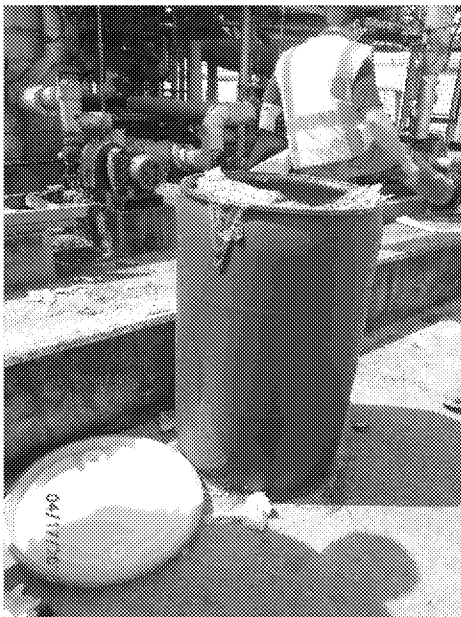
The inspectors observed a 55-gallon SAA drum of resin clean out (Picture 36) and a 55-gallon drum of hazardous waste flammable liquid acetone (D001, F003) in a yellow clam shell (Pictures 37-38). The small bung had been removed and the drum was not closed. Mr. Bastow replaced the bung during the inspection.

Picture [SEQ Picture * ARABIC] – Silo Containment Pit SAA drum

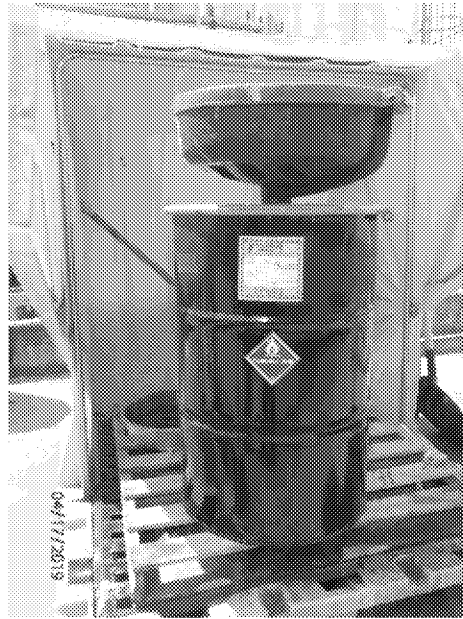
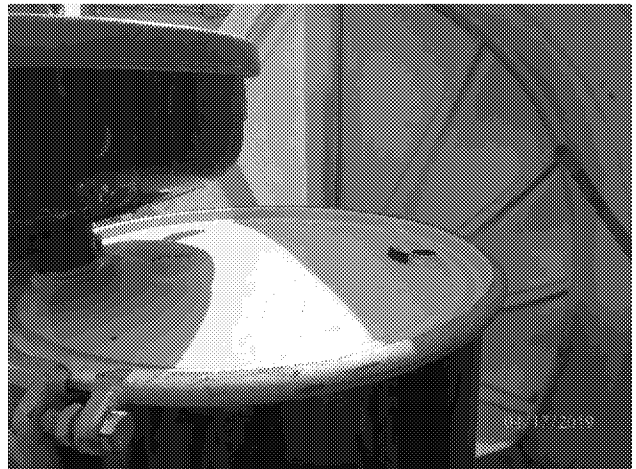
Picture [SEQ Picture * ARABIC] – Silo Containment Pit clamshell SAA open

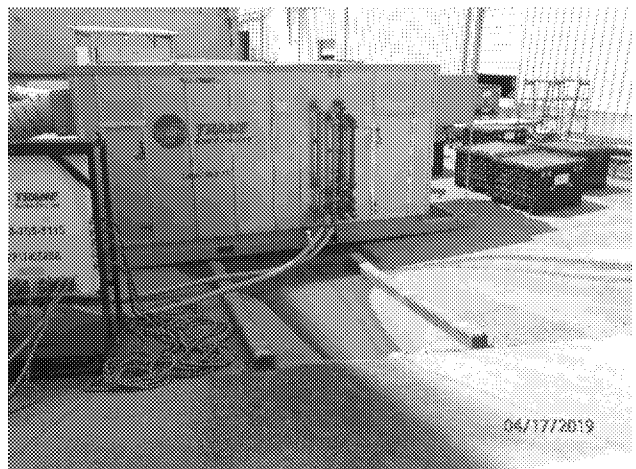
During the inspection, a stormwater discharge had occurred (Picture 39). The contractor explained that they were looking for the source of the wastewater. However, an environmental vacuum truck would pump out pit and send a sample for analysis. Mr. Schimmer, ADEM advised Mr. Bastow,

Picture [SEQ Picture * ARABIC] – Stormwater release

Mrs. Hitt and the contractor to immediately contact ADEM NPDES and notify that office concerning the discharge. As follow up to the release, the EPA was notified that the facility had not contacted the ADEM NPDES office concerning release of wastewater.

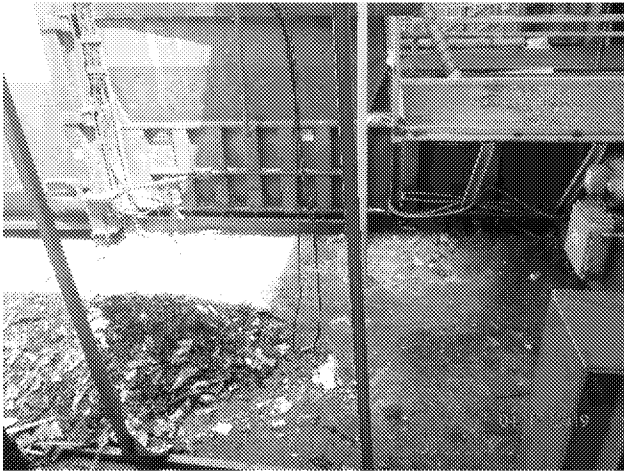
The inspectors observed the facility compactors had leaked hydraulic oil on the surrounding ground (Pictures 40-41). In addition, oil dri had been applied but not clean up, so that the oil dri, trash, debris and cardboard were saturated with the released hydraulic oil.

Picture [SEQ Picture * ARABIC] – Compactor hydraulic oil leak

Pursuant to ADEM Admin. Code r. 335-14-17-.03(4)(d) [40 C.F.R. § 279.22(d)], upon detection of a release of used oil to the environment, the facility must clean up and manage properly the released used oil and other materials.

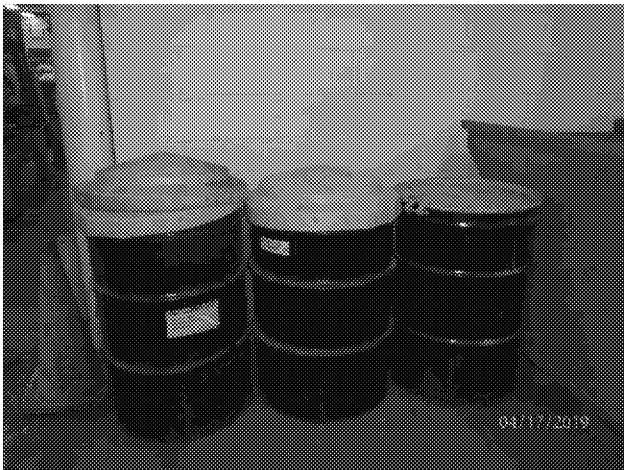
The Maintenance shop maintains the spent aerosol can drum, however the employees were unable to located the drum during the inspection. The shop had three 55-gallon drums in the area. One drum contained non-hazardous drained used oil filters, the second drum had spent alkaline batteries and the third drum had an undetermined material (Picture 42). The drum was not labeled (Picture 43).

Picture [SEQ Picture * ARABIC] – Maintenance used oil drum and an unknown drum

Pursuant to ADEM Admin. Code r. 335-14-3-.01(2) [40 C.F.R. § 262.11], a person who generates a solid waste, as defined in ADEM Admin. Code r. 335-14-2-.01(2) [40 C.F.R. § 261.2], must determine if that waste is a hazardous waste following the methods articulated in ADEM Admin. Code r. 335-14-3-.01(2) [40 C.F.R. § 262.11].

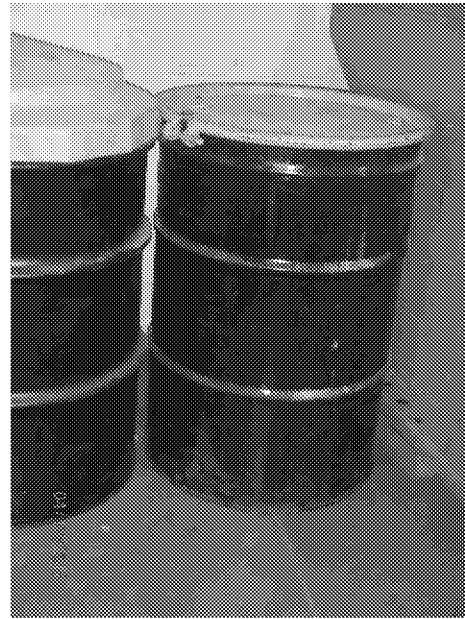
Picture [SEQ Picture * ARABIC] – Maintenance unknown drum

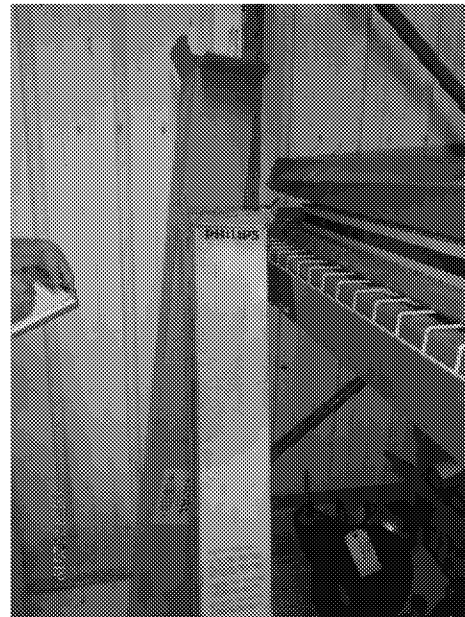
The universal waste lamps were stored in the MRO Storeroom. The inspectors observed two universal waste lamp boxes (Picture 44). The 4-foot box contained five spent fluorescent lamps and fifteen new lamps (Picture 45). The 8-foot box contained one lamp not fully contained and smaller lamps covered in bubble wrap (Picture 46). The boxes were not closed, not labeled and not dated.

Picture [SEQ Picture * ARABIC] – MRO Storeroom universal waste lamps

Pursuant ADEM Admin. Code r. 335-14-11-.02(4)(d) [40 C.F.R. § 273.13(d)], a small quantity handler of universal waste (SQHUW) must manage universal waste lamps in a way that prevents releases of any universal waste or component of a universal waste to the environment.
